SUMMIT ENGINEERING GROUP LLC

Re: Comfort Station and Band Stand Building
Clifton Heights Park
6100 Simpson Ave.
St. Louis, MO 63139

Per your request, I visited the building at above referenced address on Dec. 14, 2023 and May 1, 2024 to observe the conditions of the existing comfort station building. It was sunny when both field observations were conducted.

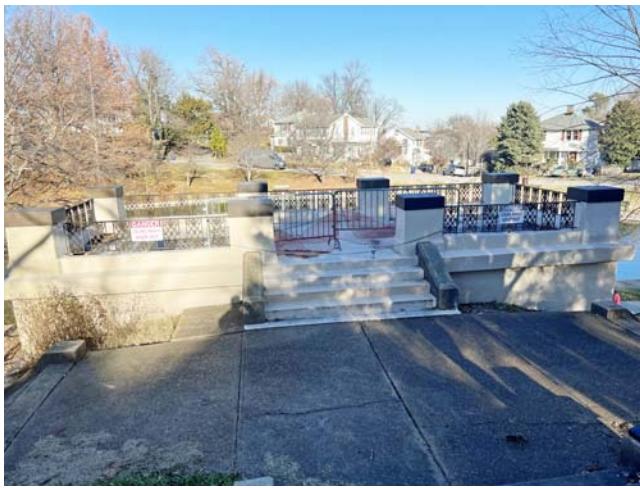
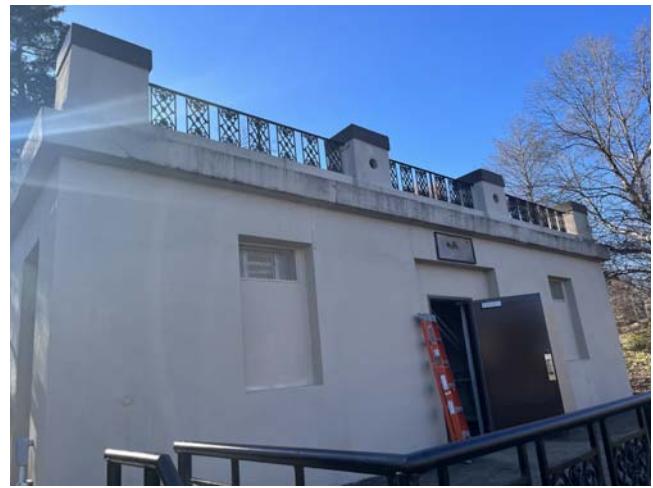
1. The figures 2 and 3 show the rear and front elevations of the comfort building. The front of the building faces the lake with 2 concrete stairs leading up to the rear of the building. The building roof level is for band stand and building lower ground level consists of tool room, coal bin, man's and woman's bathrooms.

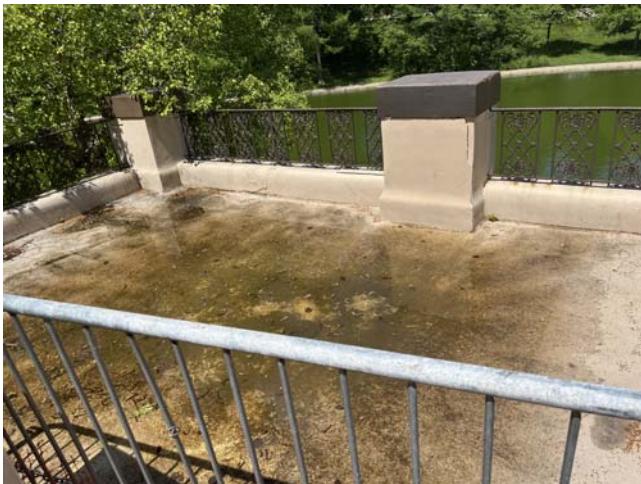
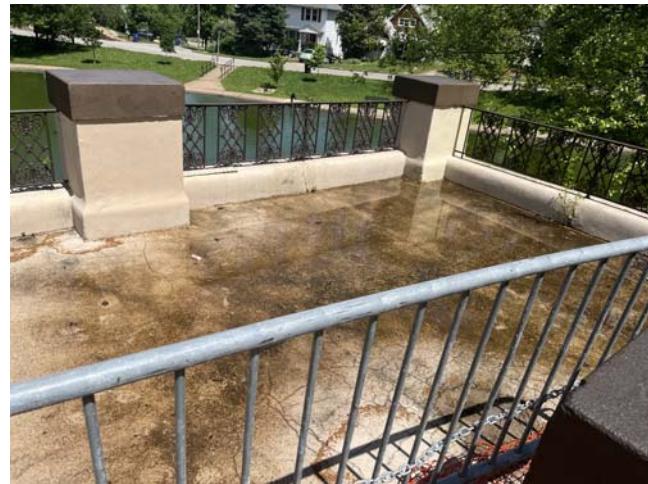
2. There was sitting water on the roof during the site visit on May 14, 2024 as shown on figures 4 and 5. Two existing roof drain outlets appeared to be clogged.

1. The existing roof structure has failed due to years of water leak over the time. The roof structure should be removed.
2. The existing exterior and interior walls consist of hollow clay tile walls based on field observation and existing building drawings provided by City public works department. Majority of hollow tile walls have high moisture contents and may have reduced load bearing capacities due to freeze and thaw cycles during the winter months over the time.
3. All concrete stairs and foundation walls appear to be in fair condition.

4. I would recommend that all existing roof structure and all hollow clay tile walls to be removed. All existing concrete stairs and concrete foundation walls should stay. New roof structural elements and new reinforced CMU walls to be installed on top of the existing building foundations.
5. The city should hire licensed architect and structural engineer to provide signed and sealed construction drawings for the existing roof and walls replacement.

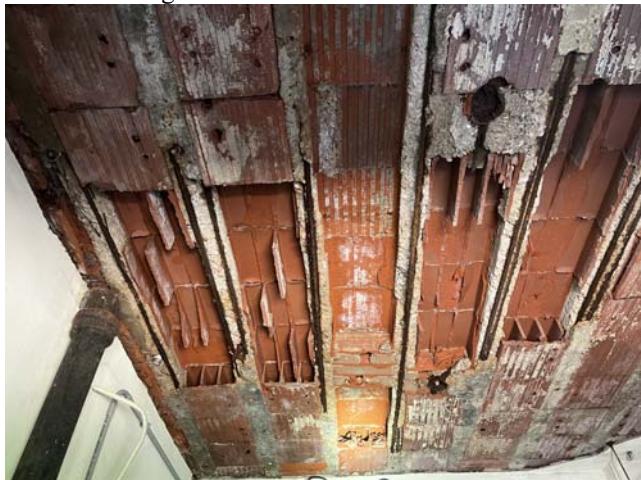
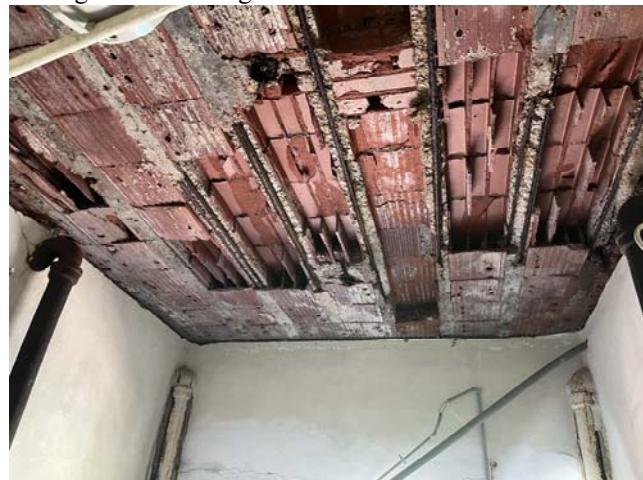
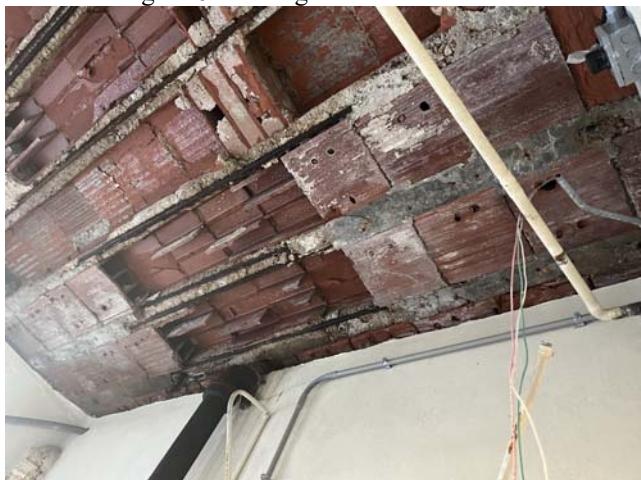
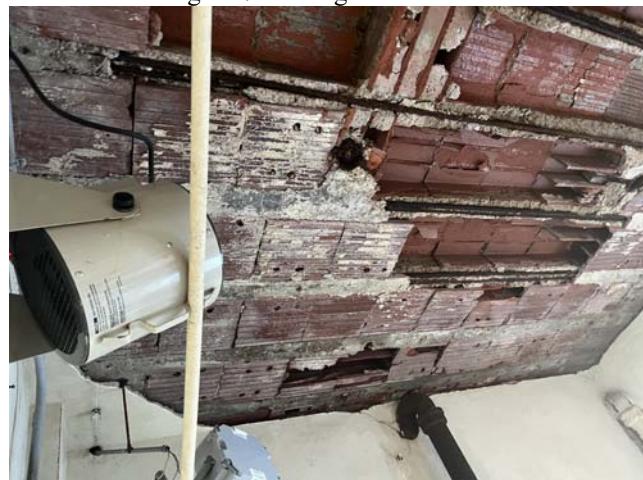
3. Viewing inside the lower level tool room, the existing reinforced concrete roof slab system over clay tile forms seemed to be in severe condition as shown on figures 6-9. Some clay tiles forms had fell off and rusted reinforcement and loose concrete were visible at the time of observation.

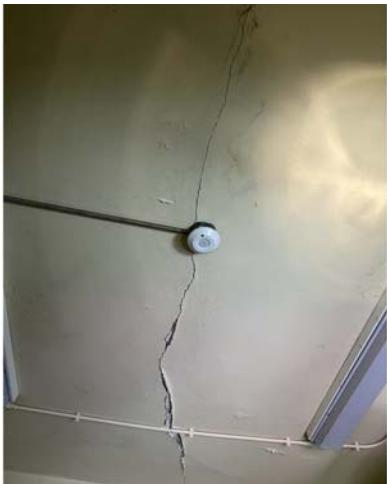
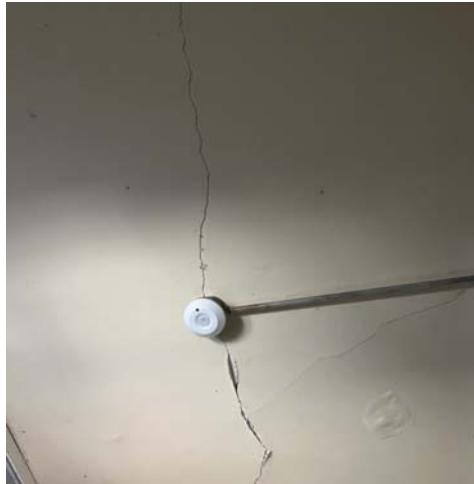
4. Viewing inside the man's and woman's bathroom, both ceilings have long cracks in the middle span of the existing concrete ceiling roof as shown on figures 10 and 11.

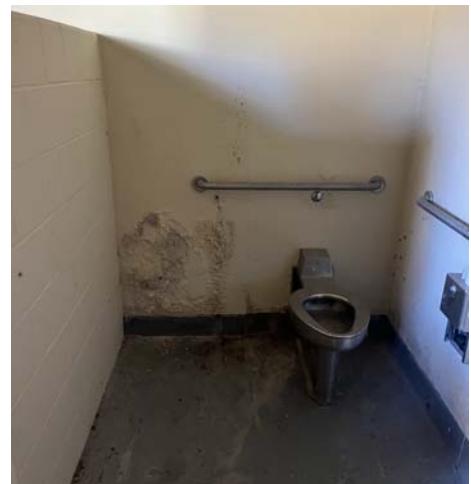
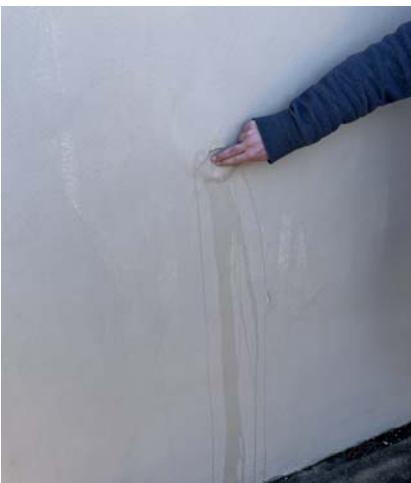
5. Water penetrations were noticed at multiple exterior walls and bathroom wall locations as indicated on figures 12 and 13. The moisture contents readings were very high at multiple wall locations by using moisture-measuring device during our site visit on May, 14, 2024.

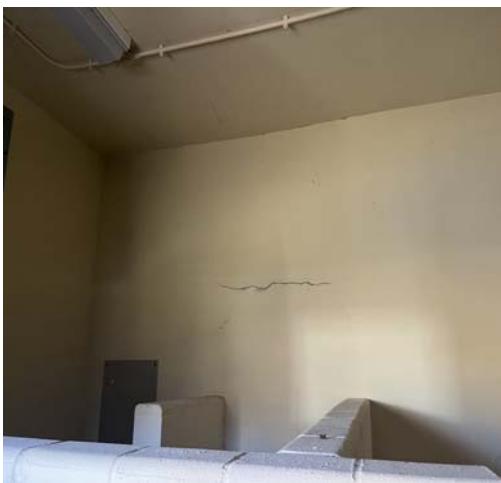
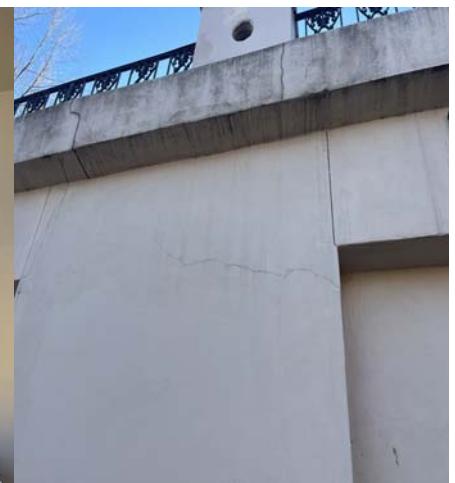
6. Multiple wall cracks were observed for exterior walls and interior walls at multiple locations as shown on figures 14 and 15.
